DEPARTMENT OF TRANSPORTATION

Contract #: 04-0120F4Cty: SF/ALA Rte: 80 PM: 13.2/13.9File #: 1.28**WELDING INSPECTION REPORT****Resident Engineer:** Casey, William**Address:** 333 Burma Road**City:** Oakland, CA 94607**Report No:** WIR-026795**Date Inspected:** 01-Dec-2011**Project Name:** SAS Superstructure**OSM Arrival Time:** 700**Prime Contractor:** American Bridge/Fluor Enterprises, a JV**OSM Departure Time:** 1730**Contractor:** American Bridge/Fluor Enterprises, a JV**Location:** Job Site**CWI Name:** Pat Swain**CWI Present:** Yes No**Inspected CWI report:** Yes No N/A**Rod Oven in Use:** Yes No N/A**Electrode to specification:** Yes No N/A**Weld Procedures Followed:** Yes No N/A**Qualified Welders:** Yes No N/A**Verified Joint Fit-up:** Yes No N/A**Approved Drawings:** Yes No N/A**Approved WPS:** Yes No N/A**Delayed / Cancelled:** Yes No N/A**Bridge No:** 34-0006**Component:** OBG Sections**Summary of Items Observed:**

WELDING INSPECTION REPORT

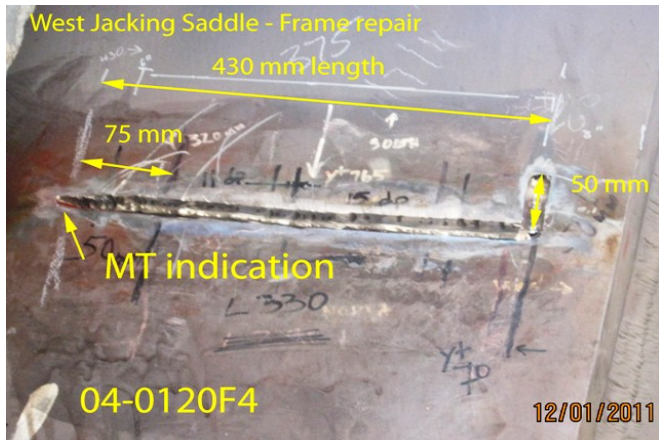
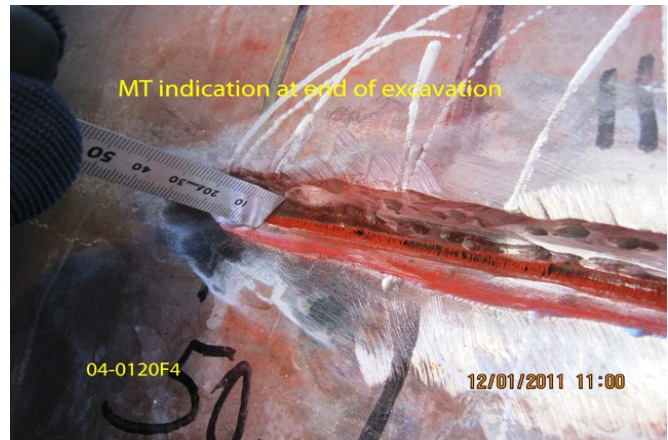
West Jacking Saddle – Frame-Repair: This QA Inspector was presented a Request For Weld Repair Approval, number 201111-003 which appeared to be for the West jacking Saddle Frame. This QA Inspector reviewed the documents and meet with QC Inspector Bernard Docena and ABF welding personnel Rick Clayborn (#2773) at the West Jacking Saddle. This QA Inspector was previously informed by Lead QA Inspector Danny Reyes that ABF had approval to proceed with the excavation of the weld repair in accordance with the request identified above. This QA Inspector observed QC Inspector Bernard Docena mark out areas for additional excavations at both ends of the existing excavation. This QA Inspector observed a 50 mm long mark on the left side centered with the existing excavation. This QA Inspector observed a 50 mm mark on the right side was at a 45 degree upwards angle. This QA Inspector notified QC Inspector Bernard Docena the mark on the left appeared to

coincide with the photograph and verbiage in the repair document, but that the mark on the right did not. This QA Inspector stated the proposed area in the document appeared to be at a 90 degree angle from the existing excavation extending upwards. This QA Inspector suggested the location on the right side be confirmed by Lead QC Inspector Bonifacioi Daquinag Jr. This QA Inspector, QC Inspector Bernard Docena, Lead QC Inspector Bonifacioi Daquinag Jr., Quality Control Manager (QCM) Jim Bowers, Structural Material Representative (SMR) Kittric Guest and QA Inspector Robert Mertz met at the West Jacking Saddle. This QA Inspector was informed by QCM Jim Bowers the additional excavation area on the right side was to be at a 90 degree angle and extend upwards. This QA Inspector observed the location of the mark was corrected. This QA Inspector observed ABF welding personnel Rick Clayborn (#2773) use the carbon arc process to perform the excavations as marked. This QA Inspector observed QC Inspector Pat Swain perform a visual and Magnetic Particle Testing (MT) inspection on the excavation areas. QC Inspector Pat Swain informed this QA Inspector no crack like indications were observed at either end of the excavation. This QA Inspector performed a visual verification and observed the effective weld throat (depth of weld metal) at the end of the additional 50 mm excavation on the left appeared to be approximately 6 mm. This QA Inspector observed Caltrans Engineer Doug Wright was present and notified him of the observation. Caltrans Engineer Doug Wright stated the effective throat needed to be approximately 14 mm and that the excavation should be lengthened. ABF Superintendent Scott Smith was present and confirmed with Caltrans Engineer Doug Wright an additional 25 mm of length would be added to the 50 mm length from the existing excavation for a total of 75 mm on the left side. This QA Inspector observed ABF welding personnel Rick Clayborn use the carbon arc process to excavate and additional length of 25 mm. This QA Inspector observed the depth of the excavation appeared to be approximately 6-7 mm. This QA Inspector observed QC Inspector Pat Swain perform a visual and MT inspection on the excavation. This QA Inspector observed a broad MT indication approximately 2 mm from the surface of the existing weld face. This MT indication was produced using an AC powered MT Yoke which is for surface indications only. The MT indications implied the effective throat of the weld was decreasing rather than increasing as the excavation length increased. This QA Inspector, ABF Superintendent Scott Smith and QC Inspector Pat Swain were informed by Caltrans Engineer Doug Wright that no additional work should be performed at this time and that the issue would be addressed as soon as possible. This QA Inspector notified Lead QA Inspector Danny Reyes of the observations noted above and was not informed of any additional work to be performed at this location this shift. See photos below of the excavation areas and MT indication.

This QA Inspector and Lead QC Inspector Bonifacioi Daquinag Jr. had a conversation regarding the Welding Procedure Specification (WPS) ABF-WPS-D15-1002-Repair referenced on the repair request. This QA Inspector and Lead QC Inspector Bonifacioi Daquinag Jr. observed QC Inspector Bernard Docena confirm the welding of the excavation was in the vertical position by using a level and protractor. This QA Inspector observed QC Inspector Pat Swain perform a MT inspection on the face of the weld as far back as accessible (approximately 150 mm) from the left side of the excavation and was informed that no indications were present.
